Report of survey of city centre seating 2019

INTRODUCTION

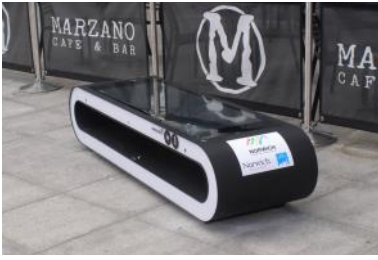
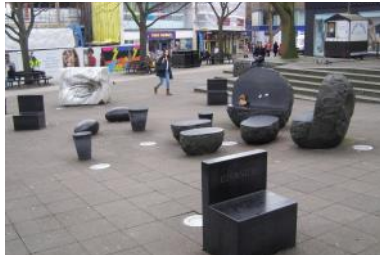
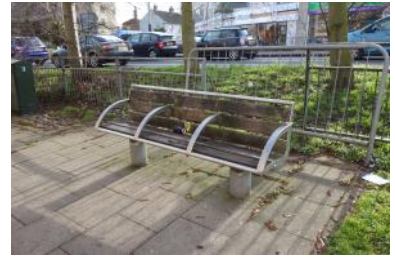
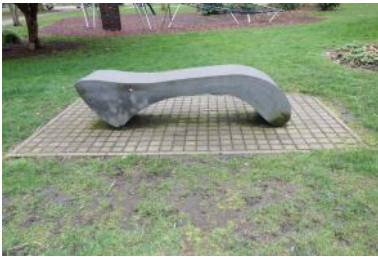
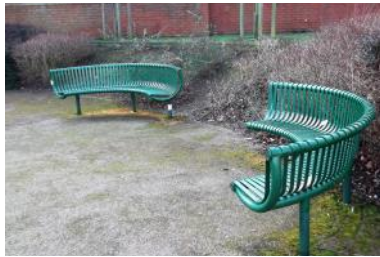
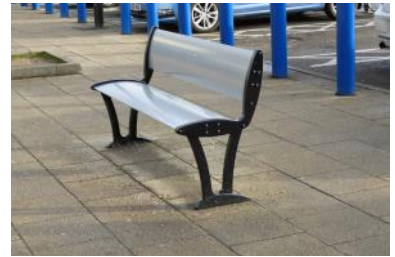
Variety of seating types

There was a greater variety of seating designs and styles than we had previously appreciated : a selection of images is shown at the end of this report.
